THEA FOSS AND WHEELER-OSGOOD WATERWAYS
REMEDIATION PROJECT

YEAR 12 MONITORING
LONG-TERM MONITORING PLAN
EVENT REPORT

NOVEMBER 16, 2018

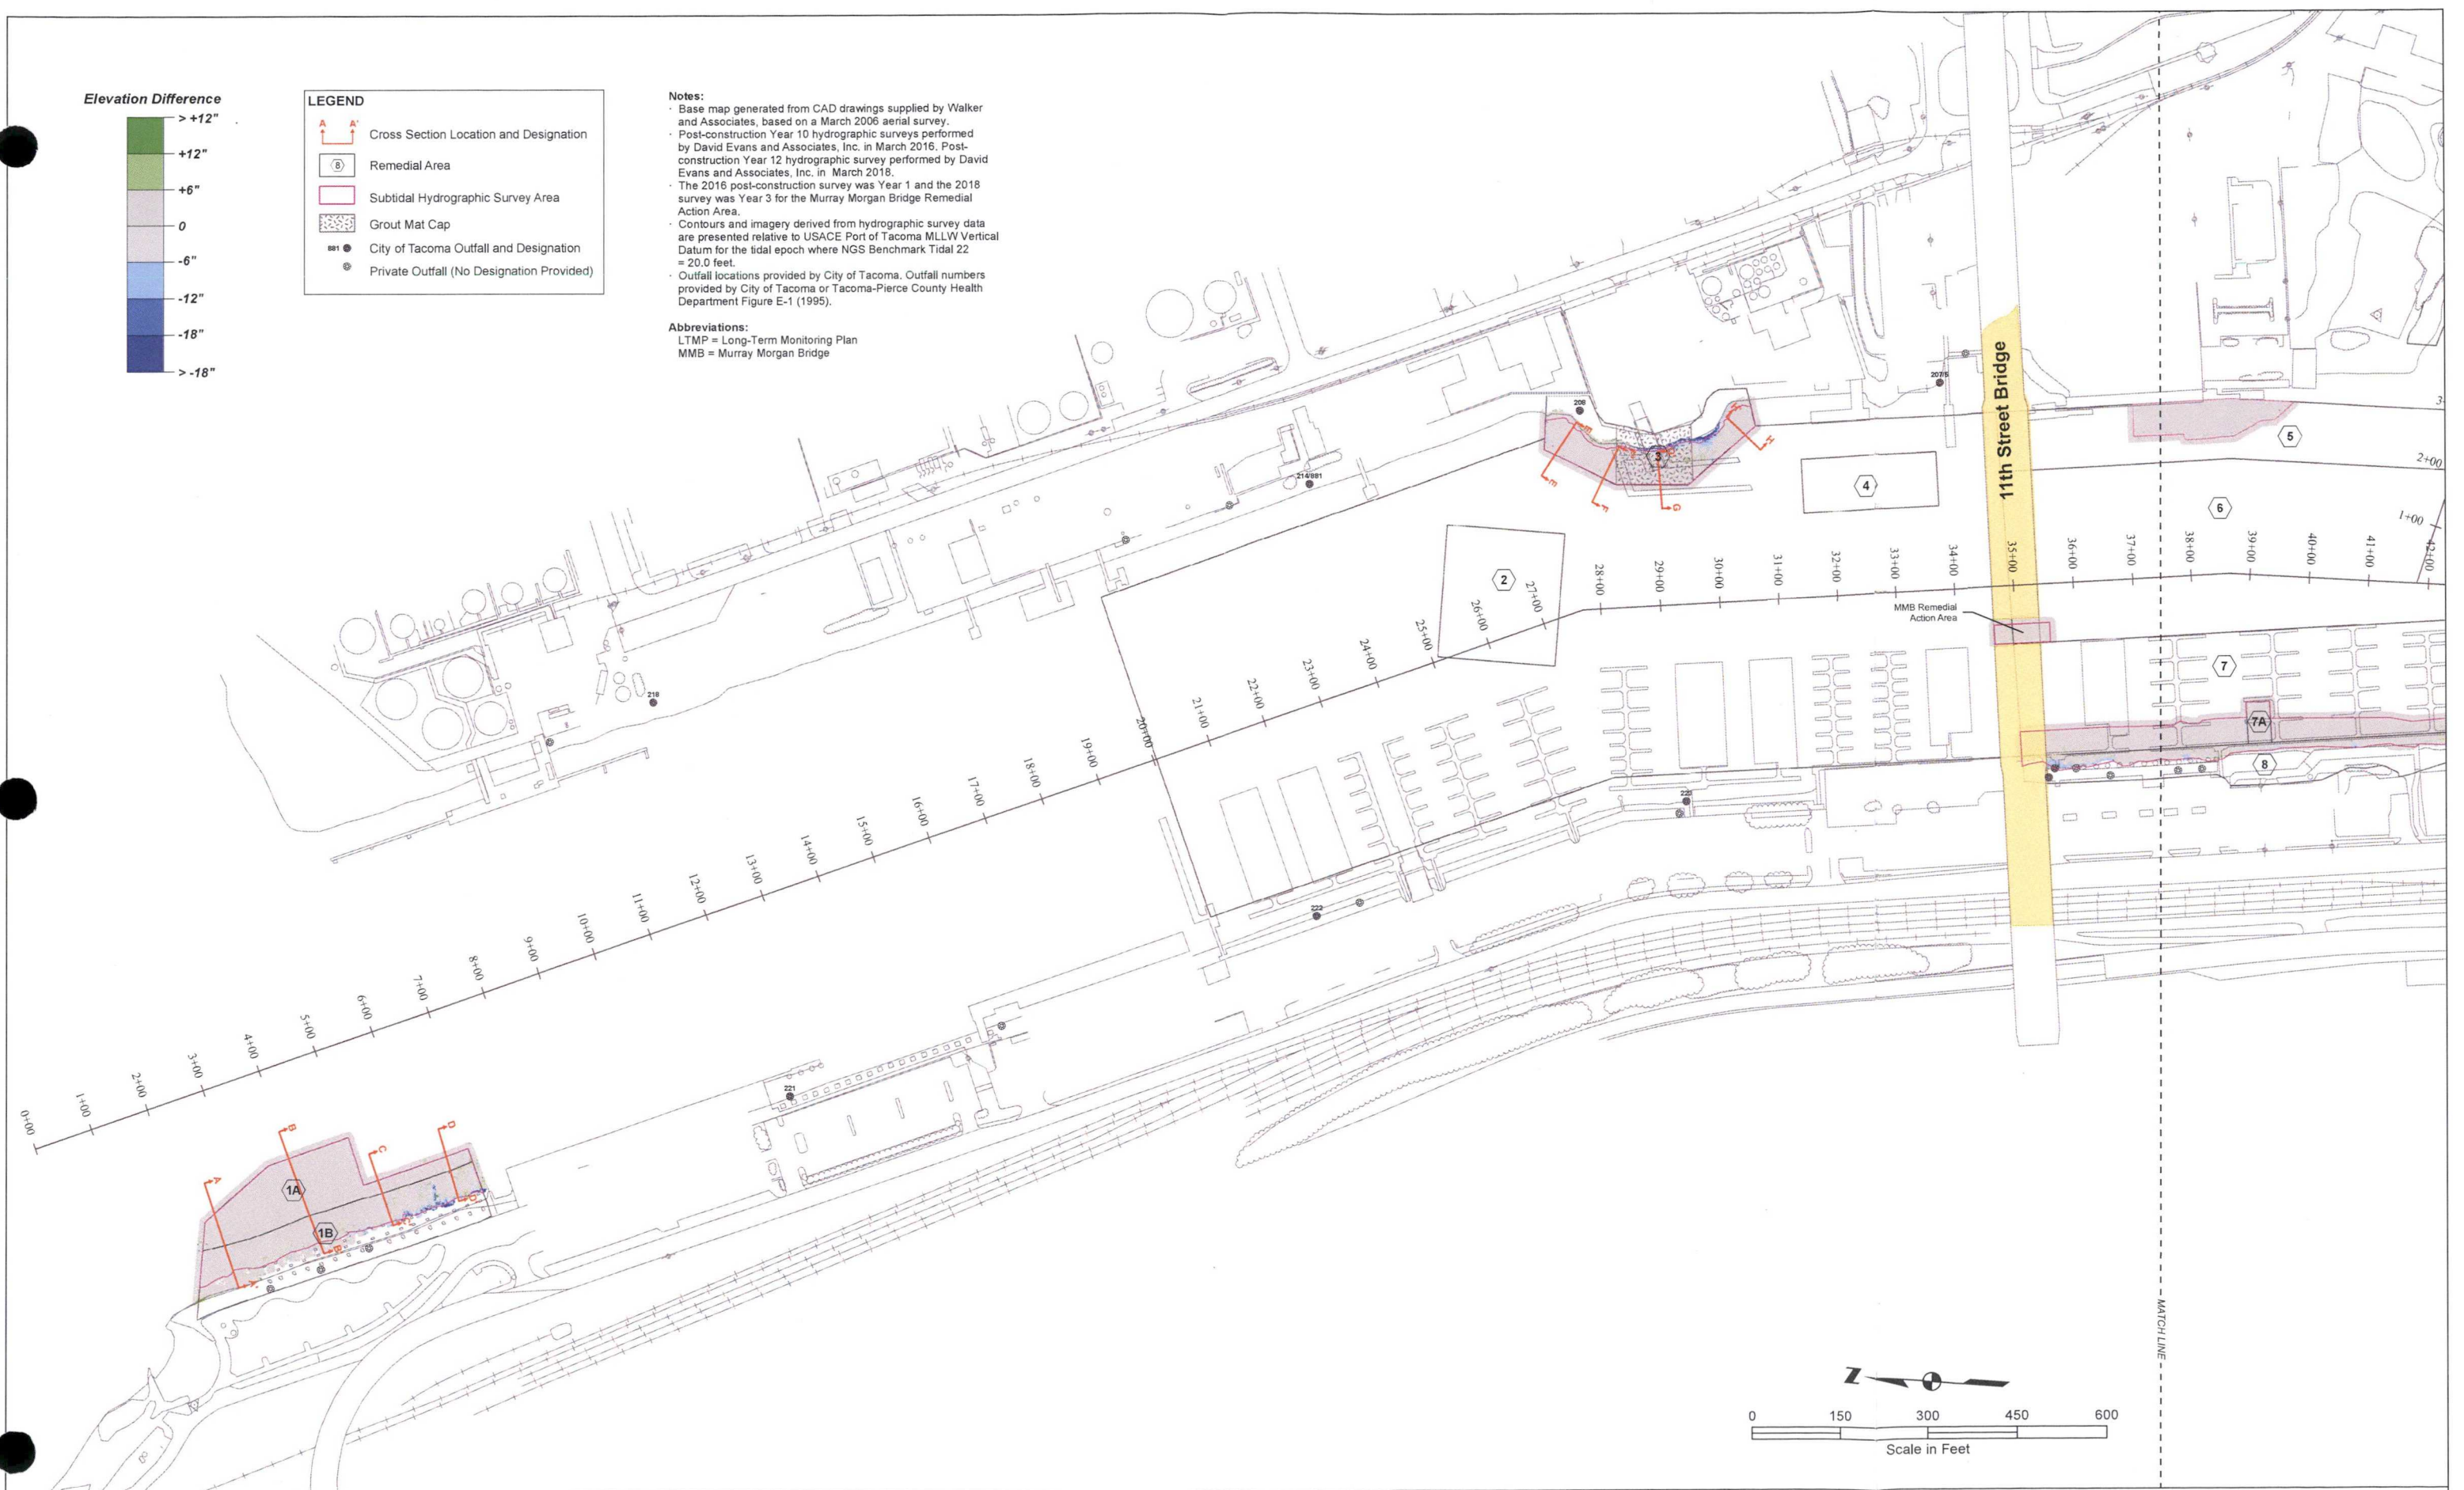
Figure 2-3 (Page 1 of 2)
Comparison of Year 10 (2016) and Year 12 (2018)
Subtidal Hydrographic Survey Results

- When comparing the Year 10 and Year 12 hydrographic survey results (refer to Figure 2-3), there were multiple slope cap locations that showed a decrease in the cap surface elevation along the upper boundary of the hydrographic surveys. These locations were present in RAs 1B, 3, 19B, and 20. These areas were all later visually inspected during the Year 12 low-tide slope cap inspections to determine if any apparent loss or erosion of material was occurring in these areas. Based on these Year 12 visual inspections, there was no apparent loss or erosion of material observed in any of these locations.

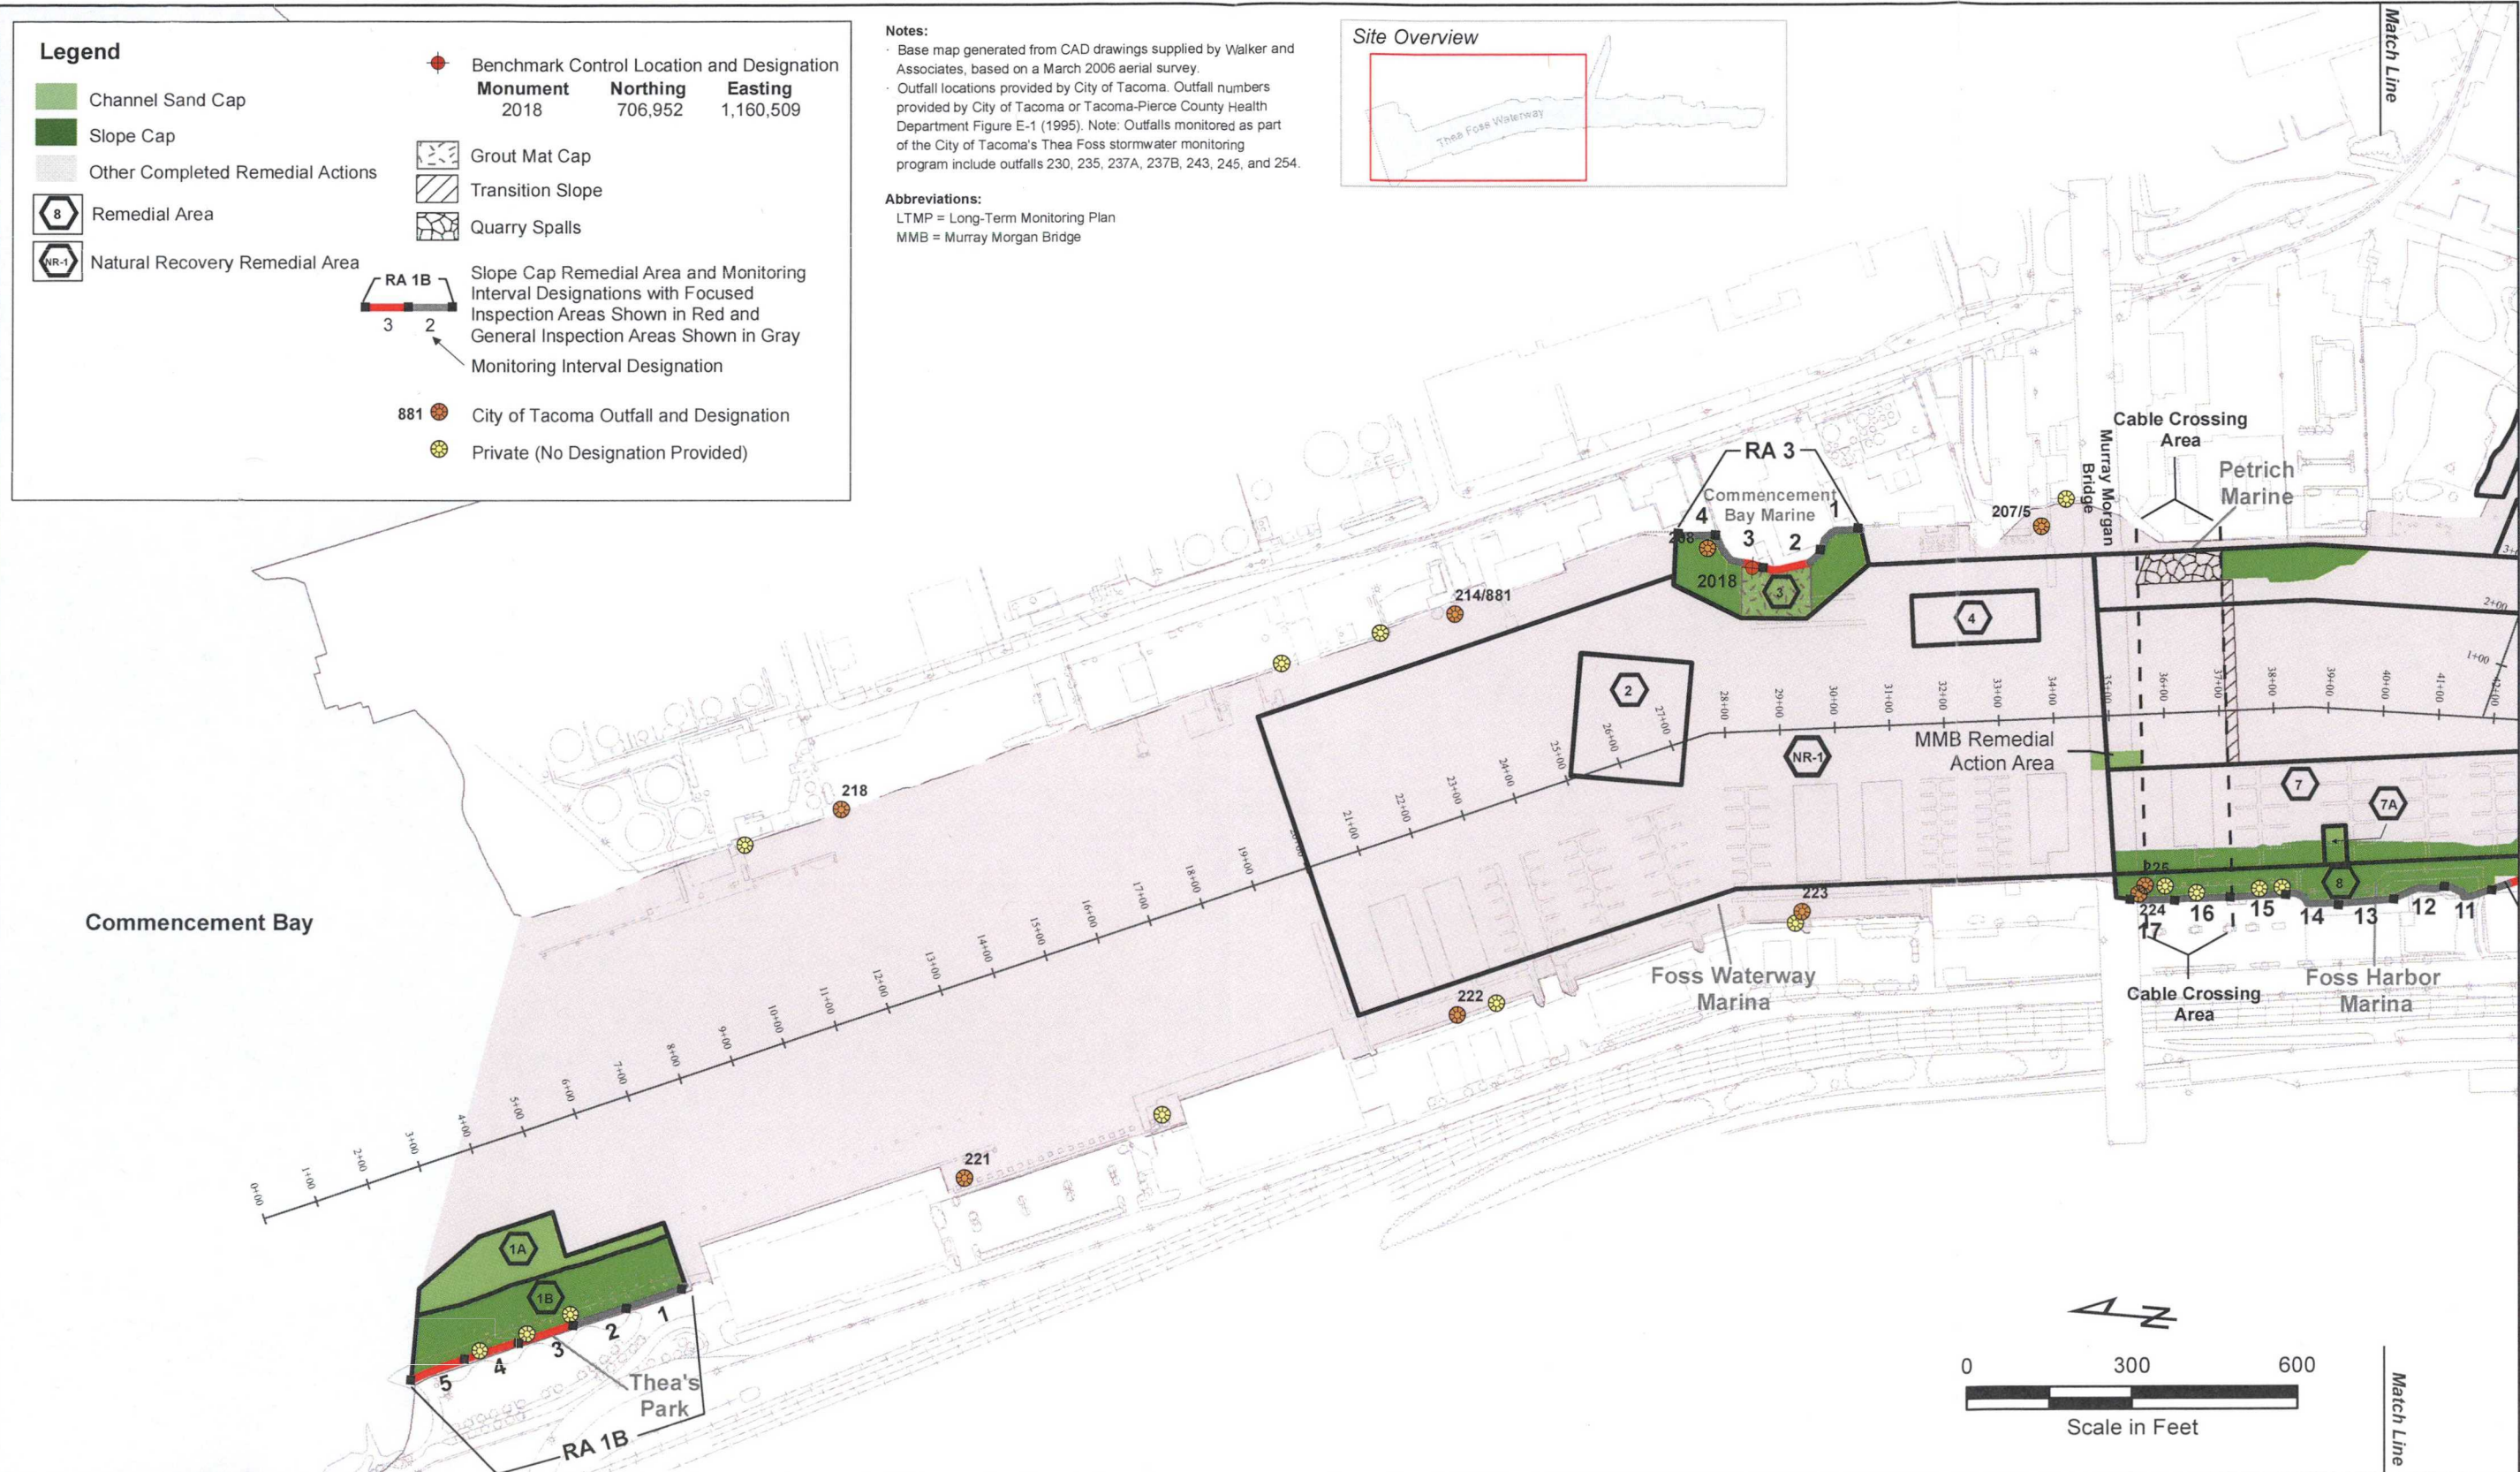
Figure 2-4 (Page 1 of 2)
Low-Tide Slope Cap Inspection Areas

- No major deficiencies were identified upon inspection of the slope caps in RAs 14, 19A, 19B, and 20.
- For the remaining RAs (1B, 3, 8, and the Sheen Source Removal Area), various slope cap deficiencies were observed in portions of these areas. These deficiencies are summarized below and include the presence of cutoff piling and possible weathering and other natural processes on the northern portion of the shoreline in RA 1B; multiple holes in the grout mat in RA 3; exposed underlying material in two upper slope cap areas within RA 3; previous downslope movement near Outfall 230 in RA 8 noted during past inspections; the presence of multiple cutoff piling and exposed

geotextile fabric in a portion of RA 8 (Monitoring Interval RA-8-10); exposed underlying material in a slope cap area within RA 8 (Monitoring Interval RA-8-14); and sheen observed on ponded water at the base of the slope in the Sheen Source Removal Area.

- RA 1B: Two of the five monitoring intervals in RA 1B were observed to have piling ends present at the surface of the capped area (Monitoring Intervals RA-1B-4 and RA-1B-5). A total of thirteen piling ends were observed in these two monitoring intervals during the Year 12 inspection. During the Year 10 inspection, twenty piling ends were observed in these two monitoring intervals. The variation in the number of piling ends observed between the inspection years is likely attributable to these piling ends being difficult to identify as they blend in well with the riprap and slope. The piling ends do not appear to be impacting the integrity of the cap or containment of the underlying contaminated sediments.

- RA 3: During the Year 12 inspection of RA 3, eight, and possibly nine, holes were observed on the surface of the grout mat in Monitoring Intervals RA-3-2 and RA-3-3. Five of these holes were not previously observed during the Year 10 inspection; however, the new holes observed in Year 12 are generally 2 inches in diameter or smaller. One of the holes observed during previous slope cap inspections has increased in size and is now 10 to 12 inches in diameter. This hole also extends through both layers of the grout mat fabric, with no grout visible between the fabric layers. Two of the other holes previously observed in the Year 10 inspection appeared as depressions, and not holes, on the grout mat surface during the Year 12 inspection. The size of the depressions in these two places does not appear to have increased substantially over the past two years. One of the grout mat holes is located above the

In Monitoring Interval RA-8-10, seven piling ends and exposed geotextile are present near the low-tide waterline along a portion of the slope cap area. This area was first observed during the Year 4 inspection and there appeared to be some additional downslope movement of riprap near these pilings between the Year 4 and Year 7 inspections exposing additional geotextile. However, minimal additional downslope movement was apparent when comparing observations from the Year 7, Year 10, and Year 12 inspections, based on the amount of geotextile exposed on the slope and the heights of the pilings' ends above the slope cap surface. These observations indicate that this area has remained relatively stable over the past 5 years. No response action is proposed in this area and this area will continue to be monitored during future LTMP monitoring events as a focused slope cap inspection area.

- **Area with Exposed Underlying Material in RA 8:** Two locations were observed near the top of the slope within Monitoring Interval RA-8-14 where underlying slag is now exposed at the slope surface. Both of these areas are located above the apparent high water line.

In order to ensure that the grout mat system remains functioning as intended, the City proposes conducting an additional physical inspection of the grout mat in 2 years (2020) to assess the grout mat conditions at that time, rather than waiting until the next planned LTMP slope cap inspection, scheduled for 2023. Based on the results of the additional 2020 inspection, the City may propose to perform grout mat repair work at that time. If additional repair work is proposed, the City will submit a memorandum to EPA with the City's recommendations for repairs.

It is proposed that maintenance activities be performed in these three slope cap intervals in 2019 to repair the cap surface. Any loose slag present on the slope surface will be removed and properly disposed of and the exposed slope cap surface will then be covered over with the appropriate cap materials (e.g., filter material, quarry spalls, and habitat mix). As all four exposed areas are located above the apparent high water line, this maintenance work will be conducted in the dry. A slope cap maintenance plan will be prepared and submitted to EPA for approval prior to conducting this maintenance work.

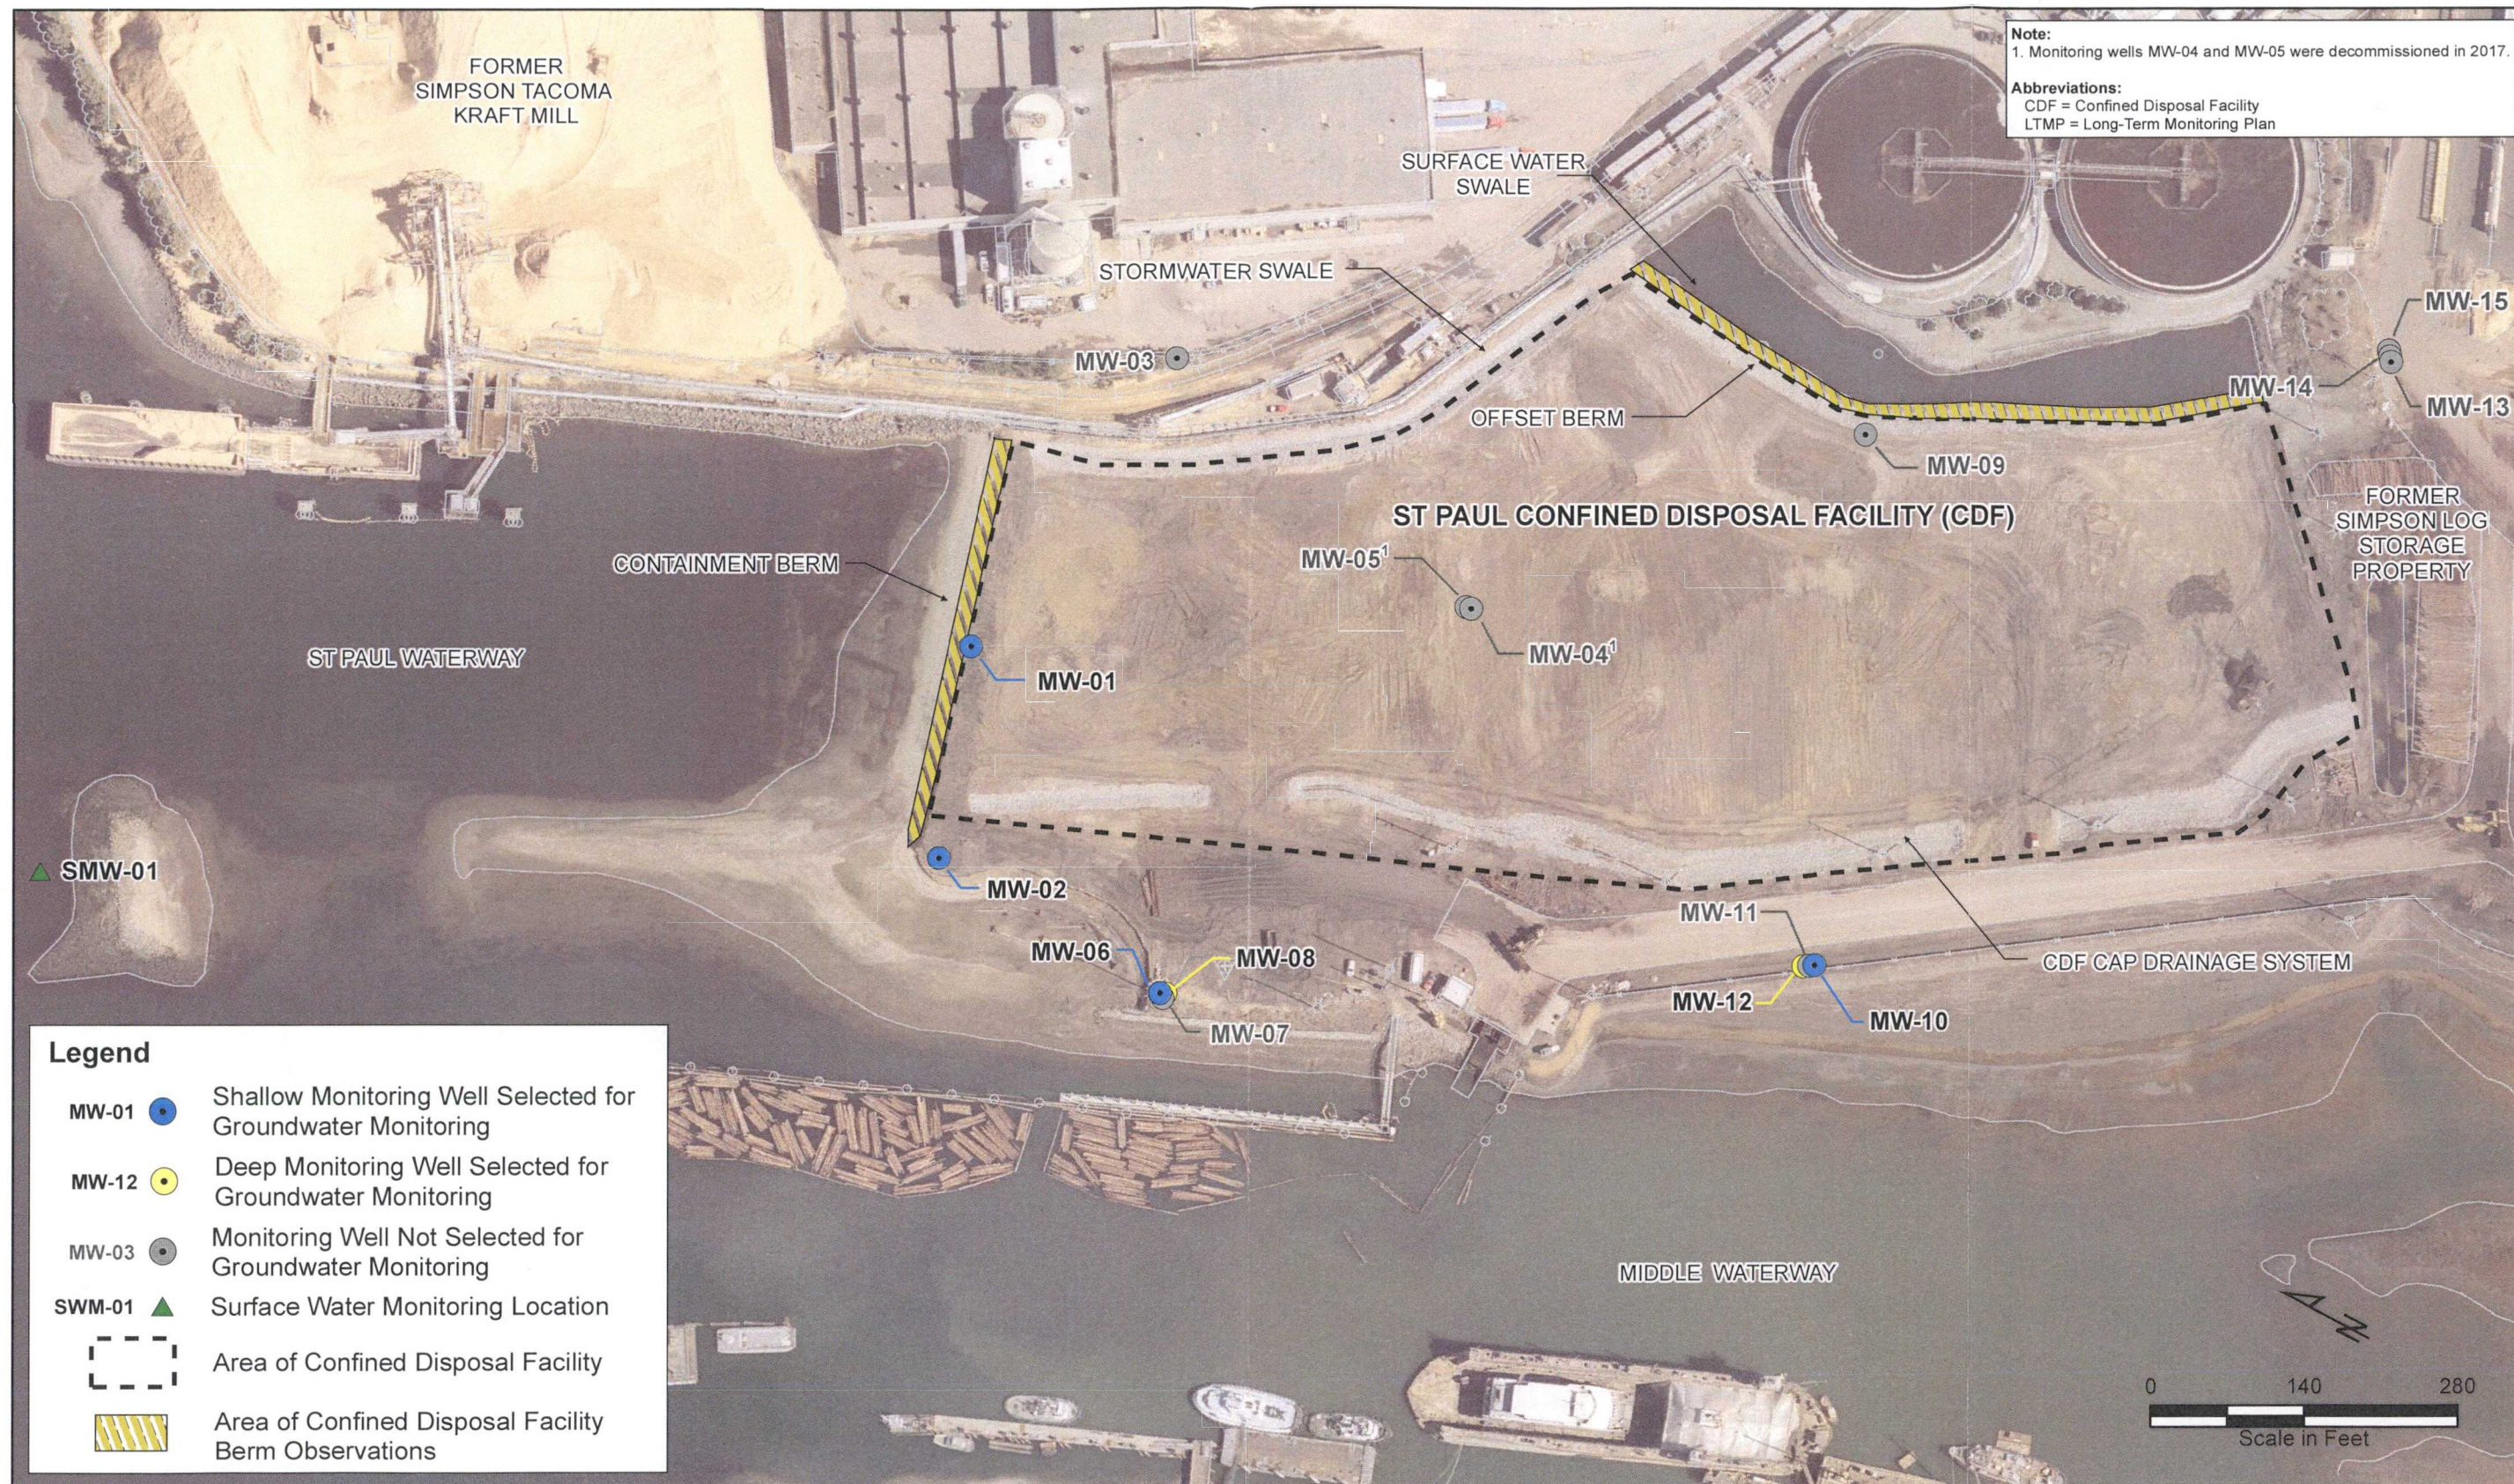
**Figure 4-2
CDF Berm and Cap Observation Locations**

- Cap and offset berm inspections have not yet been completed due to ongoing construction activities on the CDF cap.
- No sheens or other indications of contamination were identified during inspection of the containment berm.
- Consistent with previous monitoring events, seeps were observed toward the eastern end of the containment berm on the lower beach. There was no indication of contamination in these seeps.
- Some riprap remains exposed on the outward face of the containment berm at the upper slope of the beach. The area appears generally consistent and stable relative to previous observations. The containment berm does not appear to be compromised.
- Inspection of the offset berm and CDF cap will be performed when construction in this area is complete.
